**Wainui Cleanfill – GWRC Sediment Control Certification (Item 28, Consent No. WGN190237)**

Date: 25/02/2020  
 Name of Auditor: Billy Rodenburg  
 Site Condition: Dry  
 Weather Conditions: Sunny, light wind

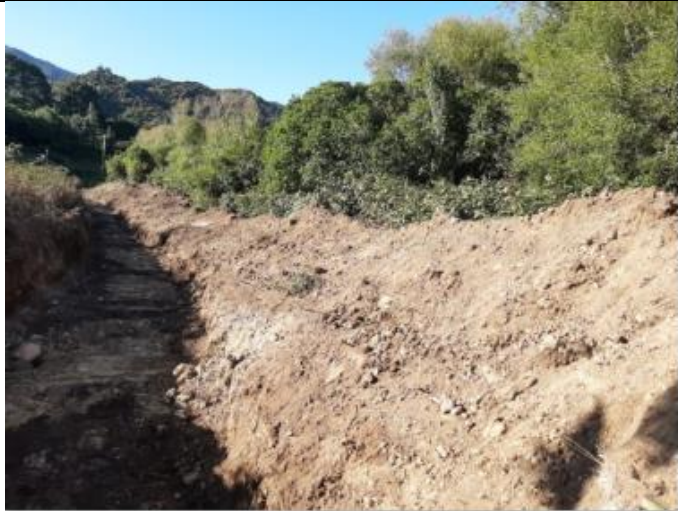
Photo	Comments
 	<ul style="list-style-type: none"> <li>• Stage 3 central soakage pit;                             <ul style="list-style-type: none"> <li>– Catchment – 0.7ha</li> <li>– Dimensions - 10m long, 5m wide and 1m deep</li> <li>– Capacity – 50m<sup>3</sup></li> <li>– Location – Between Stages 8 &amp; 9, cleanfill side of perimeter bund</li> <li>– Site fence not required due to location in middle of site, shallow depth and accessible side slopes</li> </ul> </li> </ul>
 	<ul style="list-style-type: none"> <li>• Stage 3 eastern soakage pit;                             <ul style="list-style-type: none"> <li>– Catchment – 1.1ha</li> <li>– Dimensions – 12m long, 8m wide and 1m deep</li> <li>– Capacity – 96m<sup>3</sup></li> <li>– Location – eastern side of Stage 8, Coast Road edge of cleanfill</li> <li>– Site fence installed due to proximity to Coast Road, although vegetation barrier also retained</li> </ul> </li> </ul>

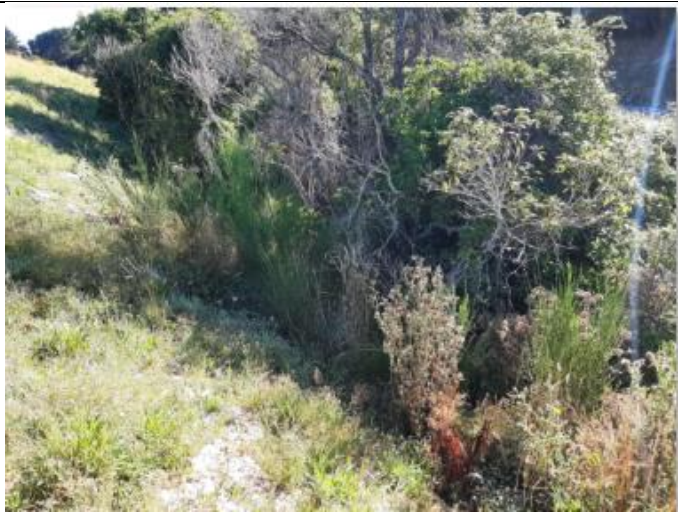
- Stage 3 Perimeter bund
  - Dimensions – at least 0.5m high, formed of topsoil stripped from inside of bund.
  - Side slopes 1V:2H
  - To be grass seeded by contractor

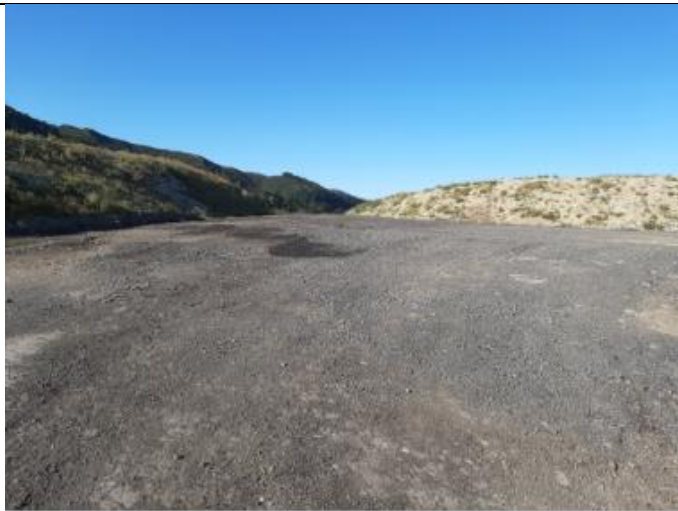
- Stage 3 clean water bypass
  - Currently installed as vegetated channel, to be extended as filling progresses

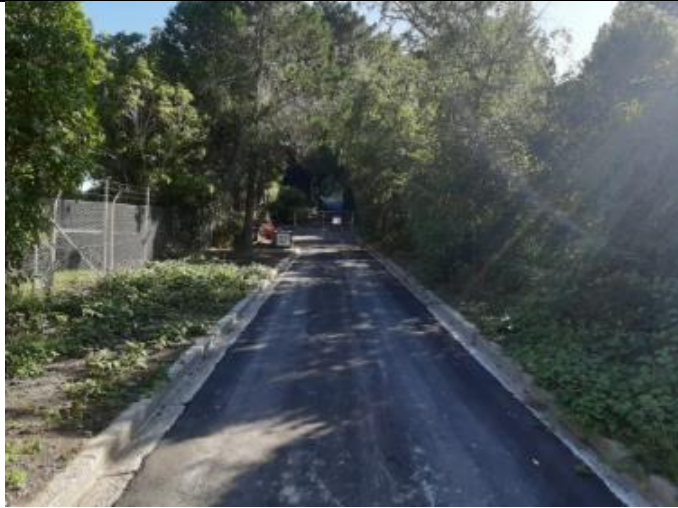
- Access roads
  - The Stage 3 access road has been stabilised with rotomillings
  - The main cleanfill access was asphalted in January

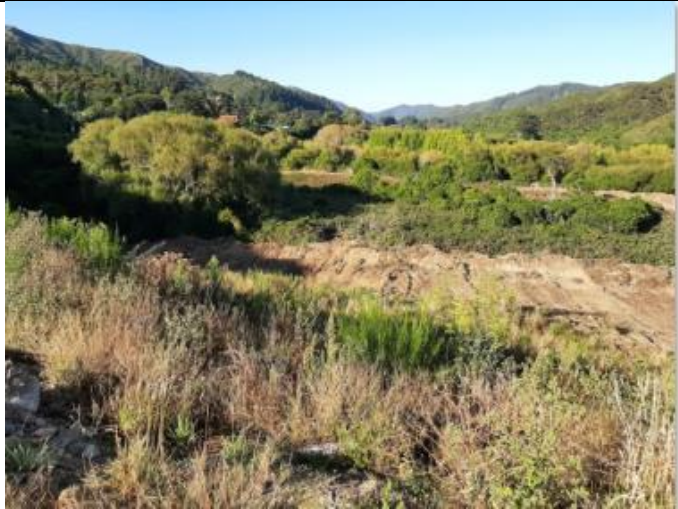
- Other notes
  - Contractor has stripped a working pad adjacent to the initial Stage 8 tip face and banded the topsoil around the perimeter to form a secondary bund within Stage 8 in addition to the minimum SMP requirements. This bund will be progressively relocated as filling progresses. (Photo left)
