**Petone Recreation Ground Grandstand
16 Udy Street, Petone**

Initial Seismic Assessment

**for
Hutt City Council**

**Initial Seismic Assessment Report
Petone Recreation Ground Grandstand, 16 Udy Street, Petone**

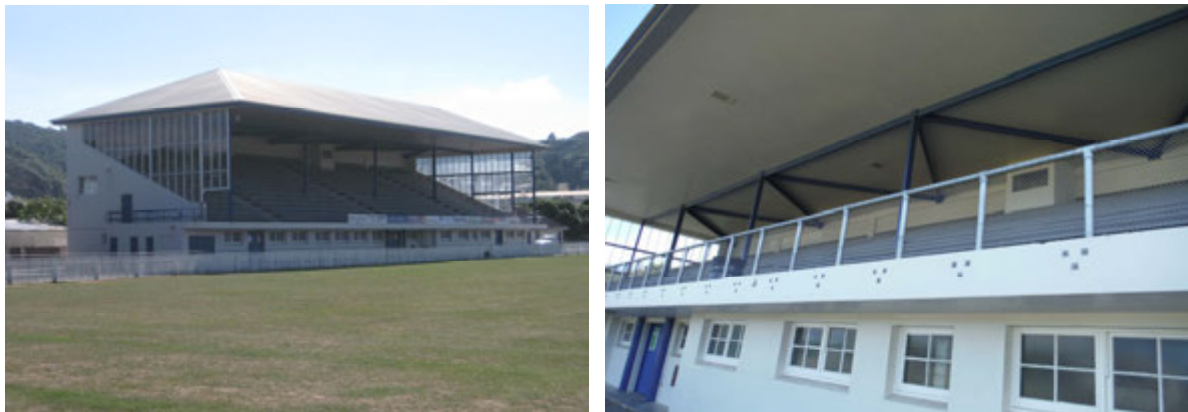
1.1 Photos (attach sufficient to describe building)

The building was originally constructed in 1939. Roof bracing was added in 1979. The grandstand was strengthened to 34%NBS (IL3) in 2014.

The grandstand has a corrugated iron hip roof supported on steel angle trusses. These trusses are supported on the rear (west) wall and steel I section columns along the centre of the grandstand. The trusses cantilever approximately 7.5m from these columns over the front of the grandstand.

The bleachers on which the grandstand seating is located are insitu reinforced concrete supported by raking insitu reinforced concrete beams.

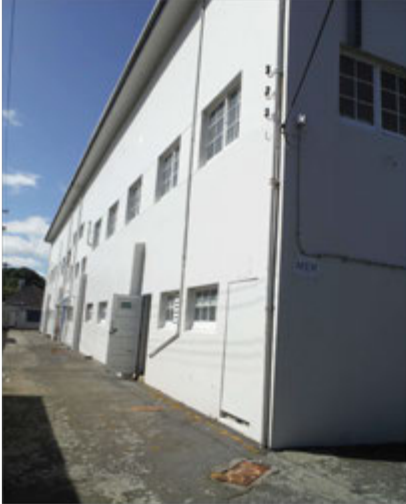
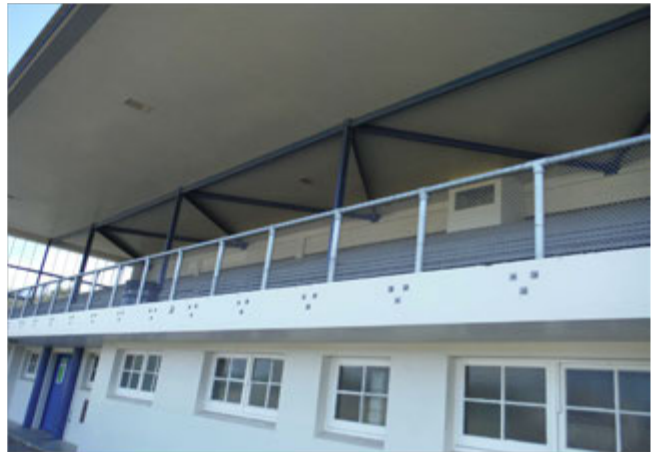
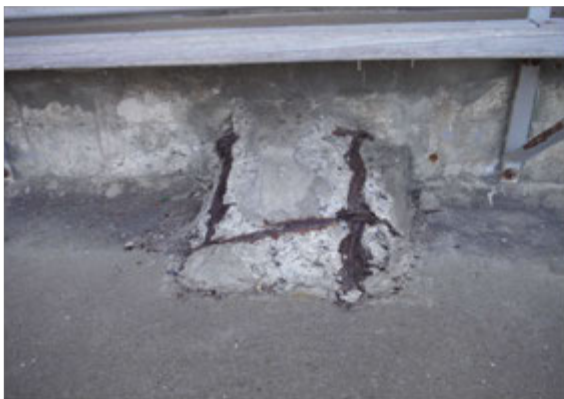
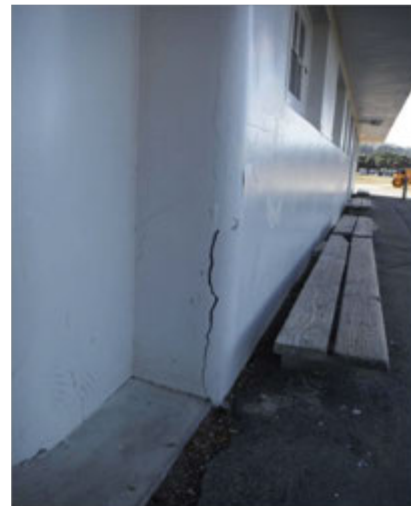
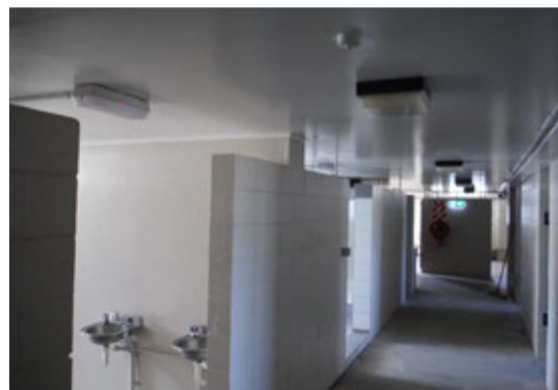
Table IEP-1a Additional Photos and Sketches

The DSA carried out in 2014 and subsequent strengthening identified a number of structural elements in poor condition. This includes significant corrosion to the following areas:

- Steel Posts at the glass walls at the north and south ends of the grandstand.
- Reinforcement in the west wall where cracking and spalling of concrete is beginning to occur.
- Top reinforcement to the bleacher support beams especially at the lower ends.
- The base of a concrete column where concrete has spalled off exposing the north eastern reinforcing bar.

The 2014 assessment and strengthening design took into account the reduced strength due to corrosion where it was identified. Based on comparison of photographs taken in 2014 and now,

the degree of corrosion does not appear to have changed significantly. The strengths used in the 2014 assessment and design are therefore expected to still be appropriate. However, without significant remedial work to reverse the effects of this corrosion and stop future corrosion it is likely that the building’s strength will degrade to a point where the corrosion reduces the building’s seismic strength to less than 34%NBS (IL3). The recommendation of structural inspections at 3 yearly intervals to monitor the corrosion and assess its effect on the building’s likely seismic strength that was made with the 2014 strengthening design therefore still stands.

A number of areas have significant corrosion to reinforcing steel and structural steel. It is recommended that structural inspections be carried out at 3 yearly intervals to monitor the corrosion and assess its effect on the building’s likely seismic strength. Remedial measures could be considered to slow down the corrosion process and possibly extend the life of the building.
